US Army Corps
of Engineers®
Engineer Research and
Development Center

Opportune Landing Site Program

Opportune Landing Site Southeastern Indiana Field Data Collection and Assessment

November 2008

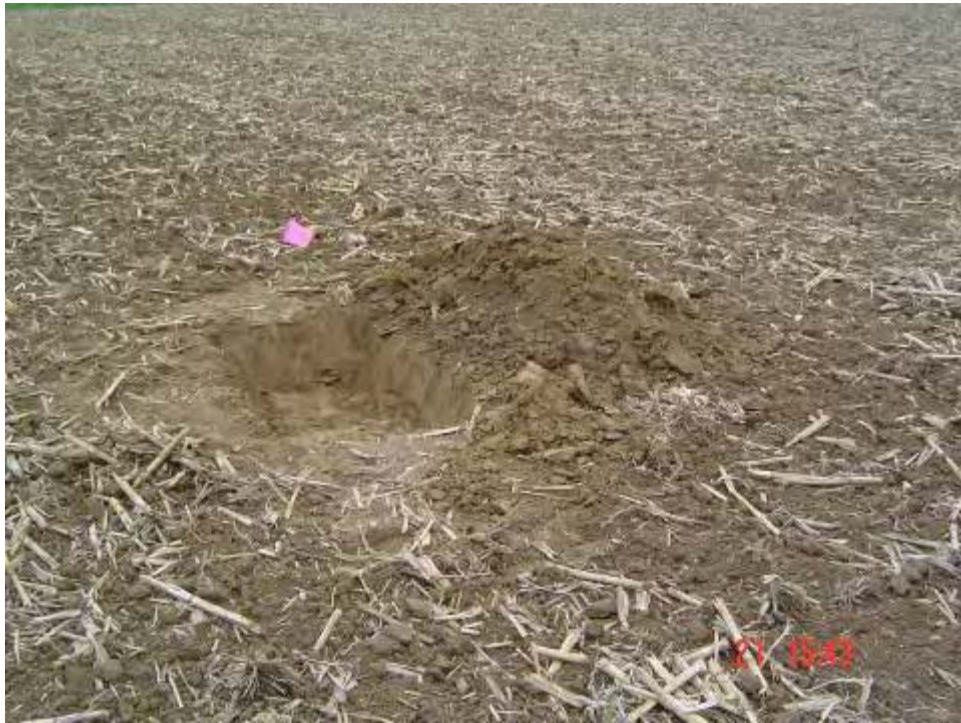
a silt material (ML) overlying CL; and the Wilbur soil is also a full-depth CL. From an engineering standpoint, the soils exhibit very similar characteristics. Photographs in Figures 7-9–7-12 show the soil pits excavated at each SAS location.

Figure 7-9. Cincinnati soil pit, upper 300 mm.

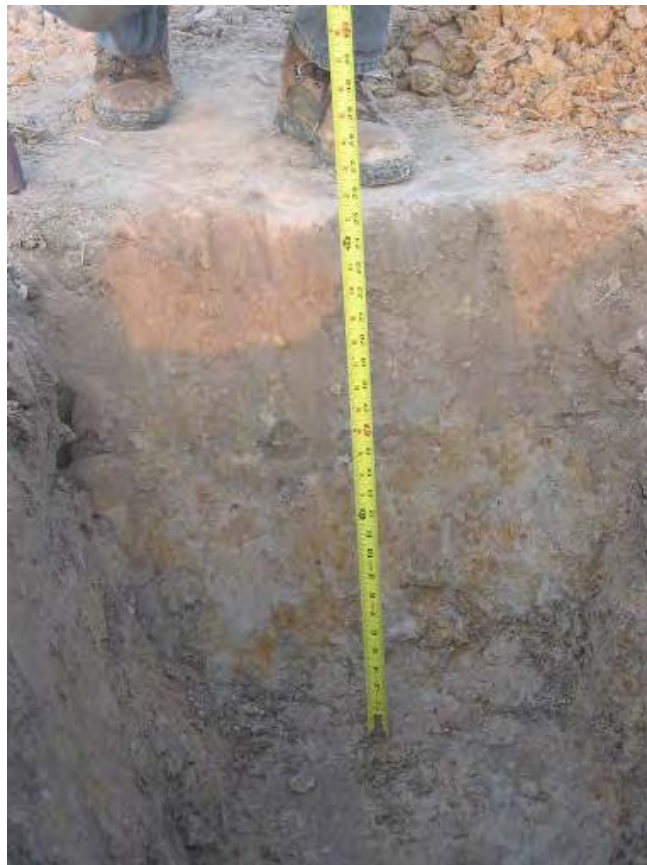
Figure 7-10. Cobbsfork soil pit, upper 600 mm.

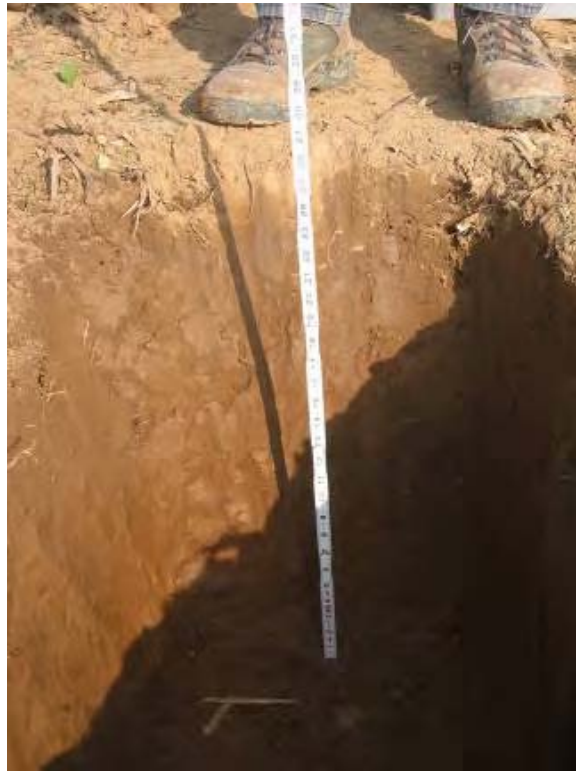
Figure 7-11. Parke soil pit, upper 600 mm.

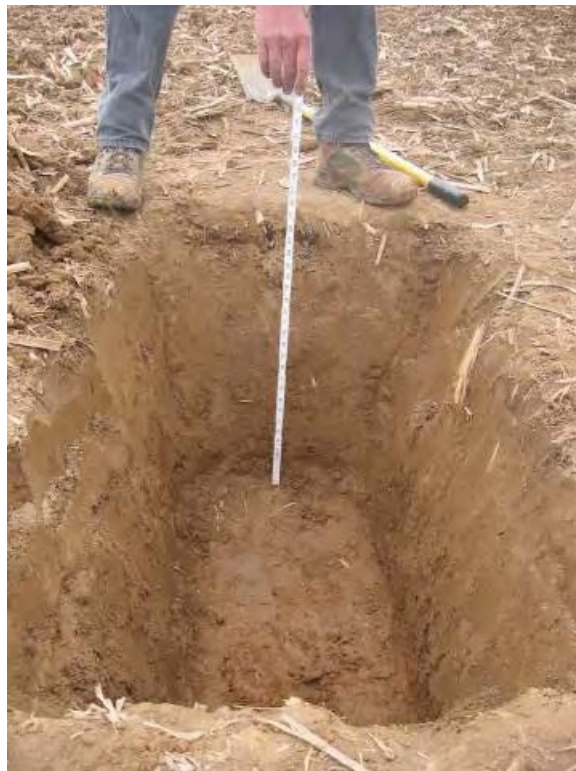
Figure 7-12. Wilbur soil pit, upper 600 mm.

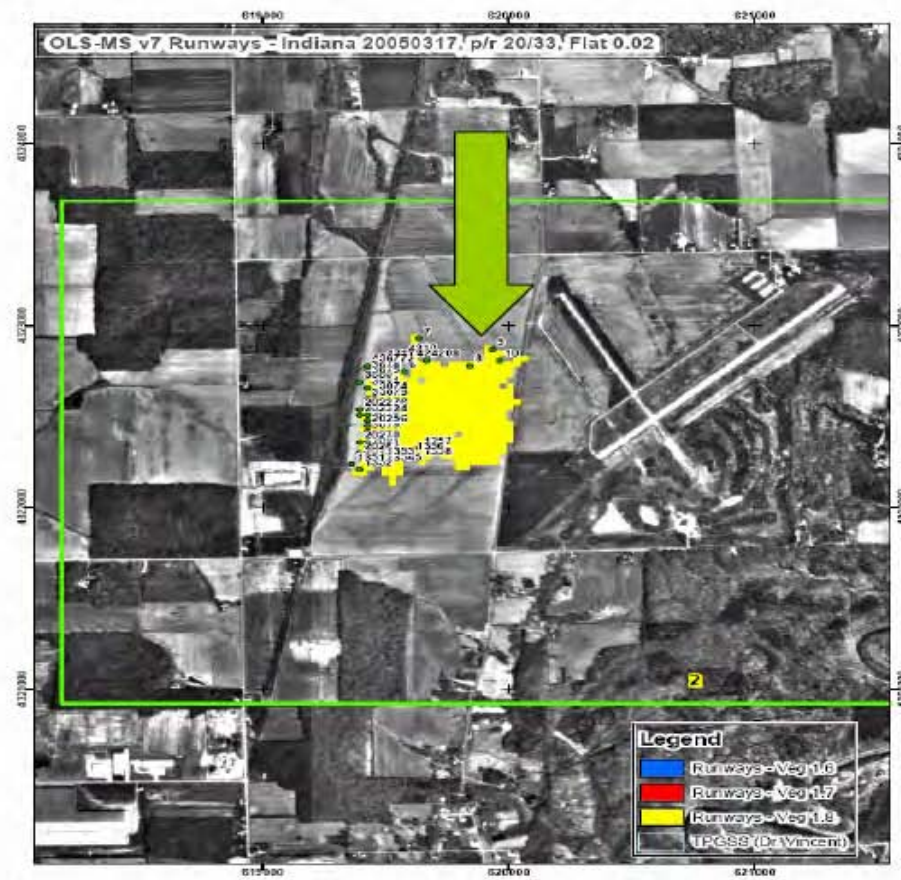
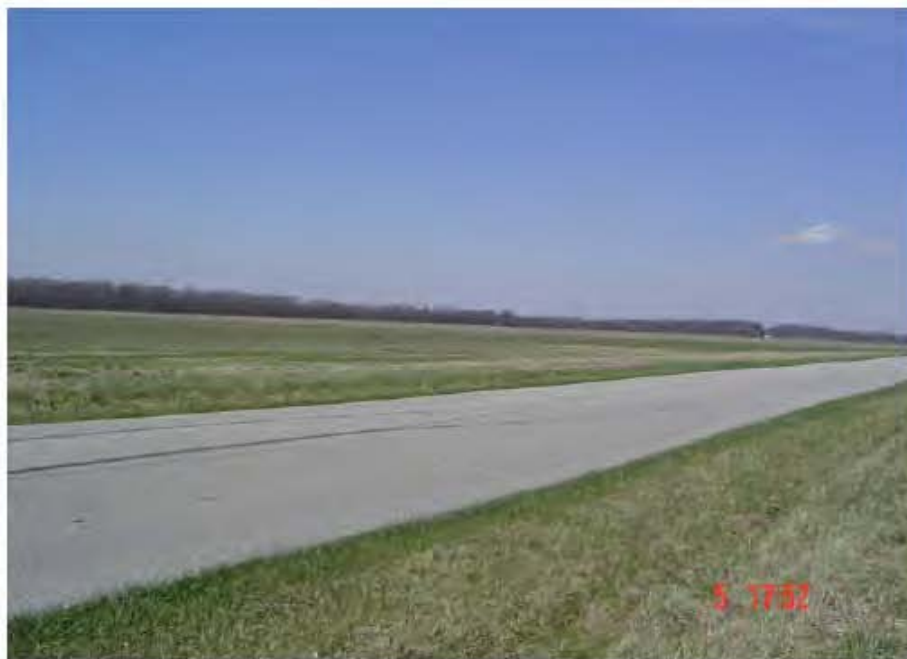
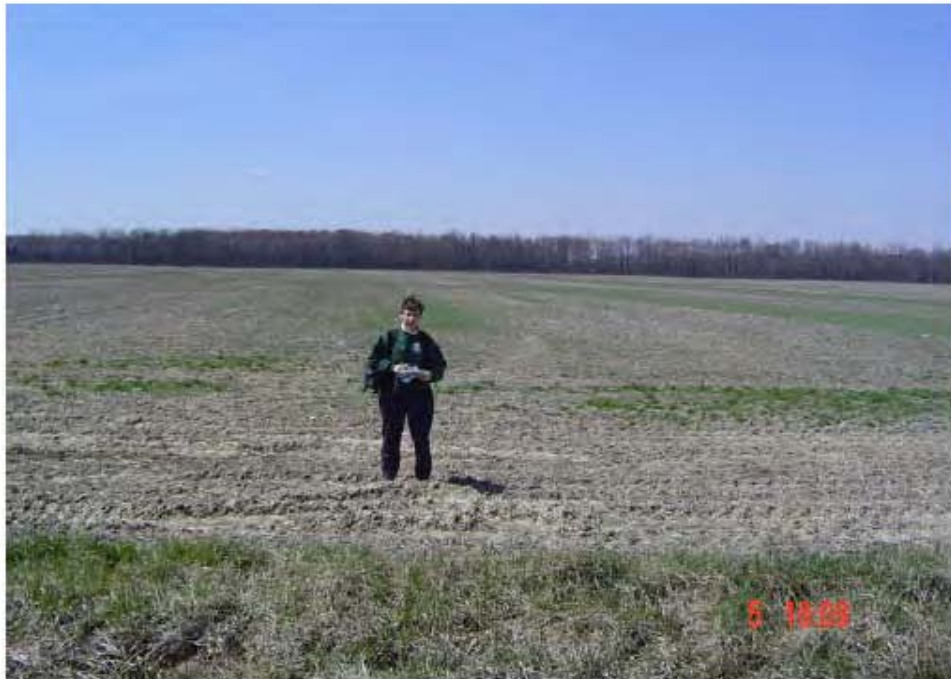
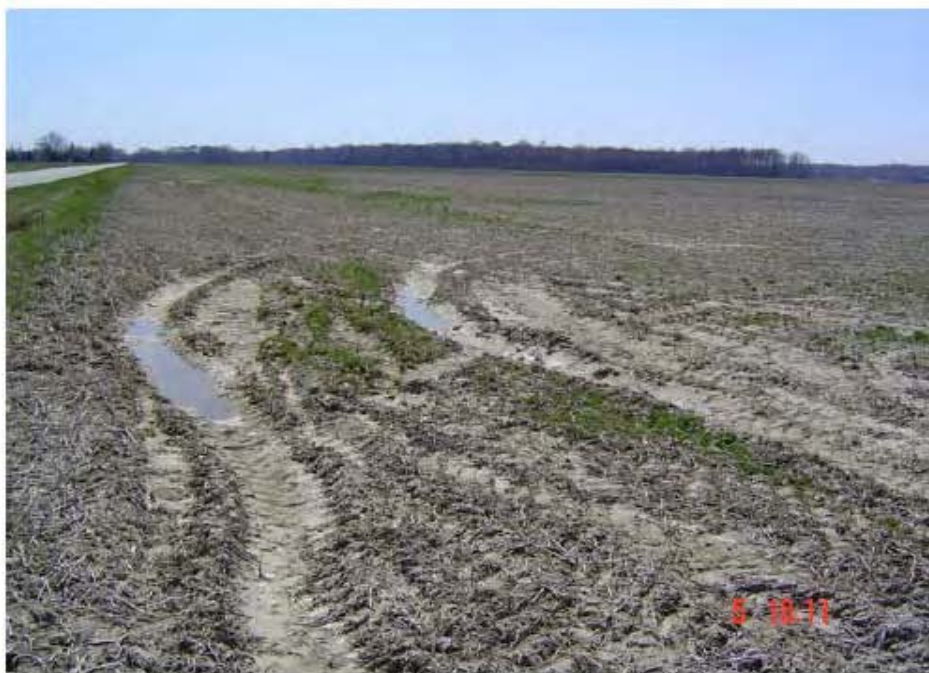
1. The first site inspected was a large cluster of OLSs in Area 2 directly across from North Vernon Municipal Airport (Figs. 2–5). The field, containing perhaps 50 OLSs, appeared quite flat, smooth, and, except for drainage ditches, obstruction free. However, the field was wet and soft. In addition, a ditch approximately 1-m deep and 3-m across crossed most of the north-south oriented OLSs. At the time, the airport was installing an AWOS weather station that would be available for data acquisition (Fig. 6).

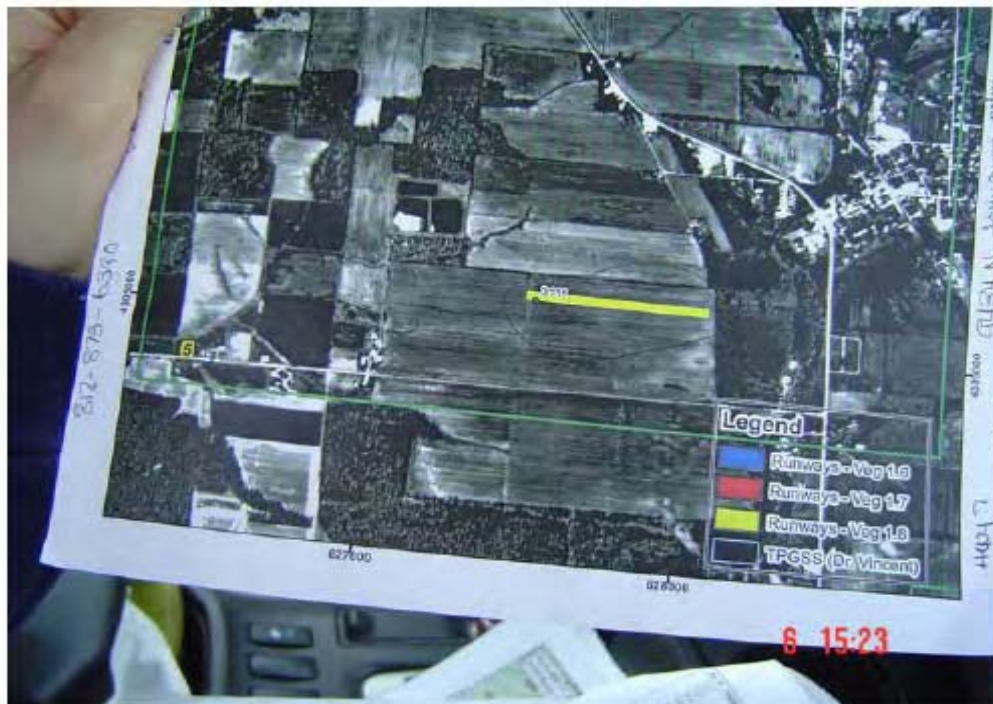
Figure 7.

2. OLS 3111 in Area 5 (Fig. 7) crossed a field from east to west. The field was smooth, flat, and apparently free of obstructions, although we did find that ditches were difficult to locate from a distance. Figure 8 shows water standing in the field, although perhaps not in the OLS.

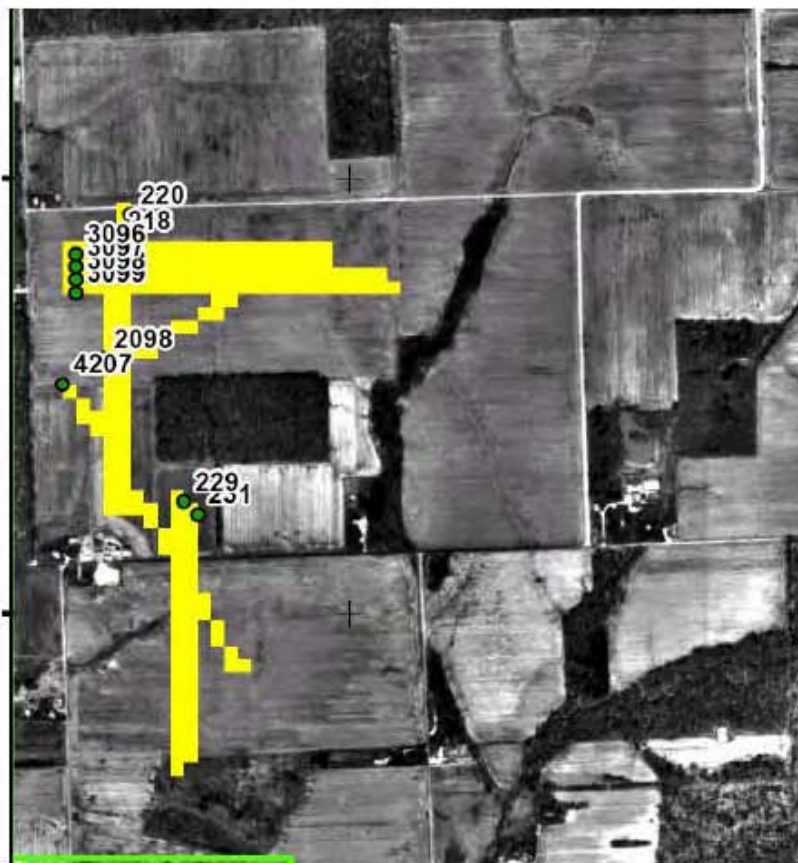
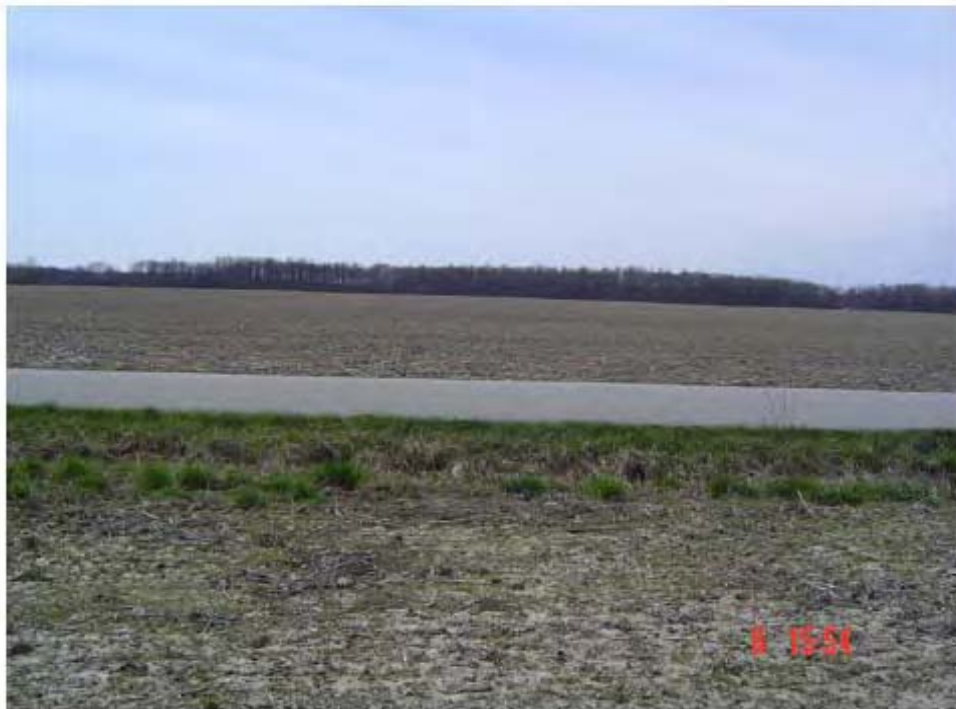
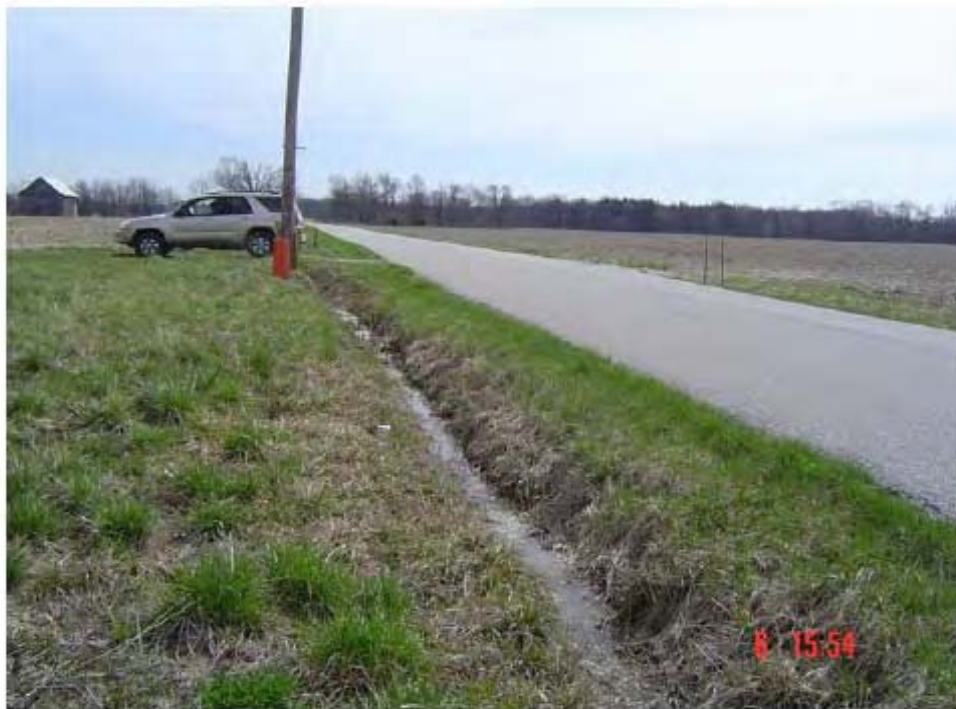
3. OLS 229 in Area 10 (Figs. 9–12) was inspected near the middle of its length where it crossed a paved road with perimeter ditches and a power line. Fields on either side of the road were flat and smooth (except for tillage and tractor tire furrows), but wet and soft. The ditch on either side of the road was about 0.3-m deep.

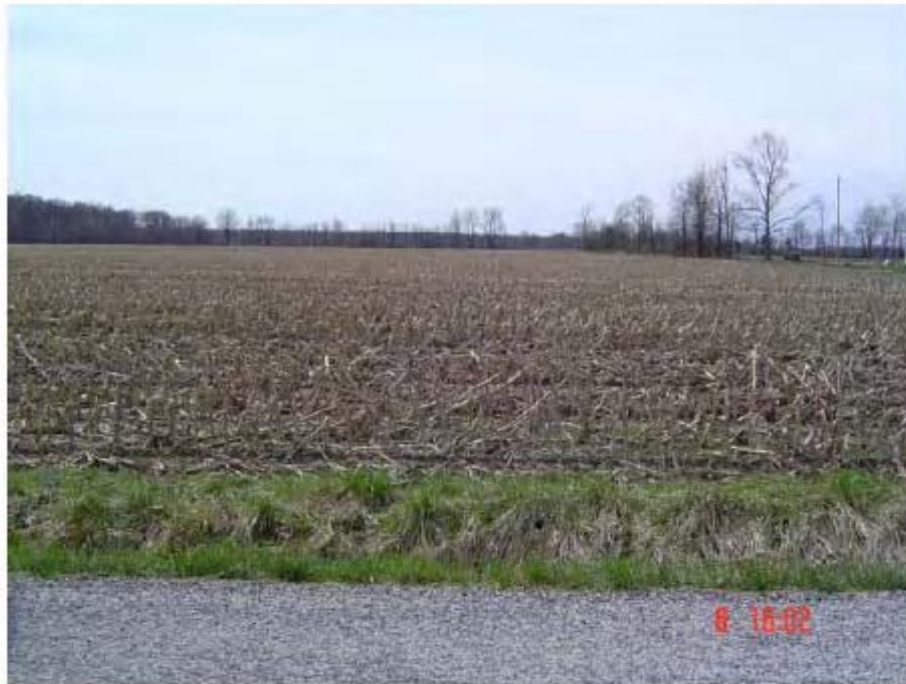
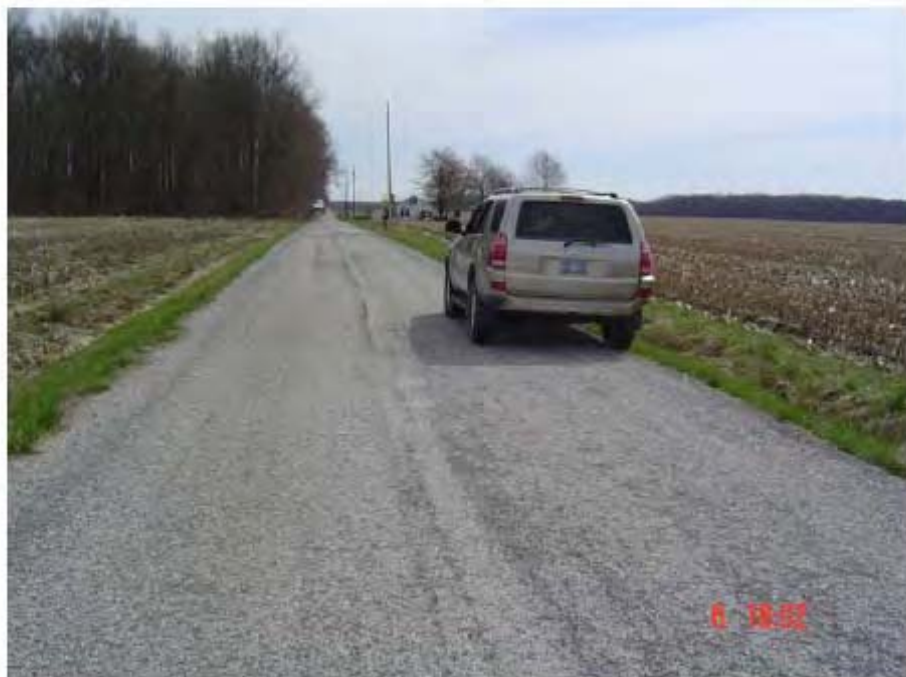
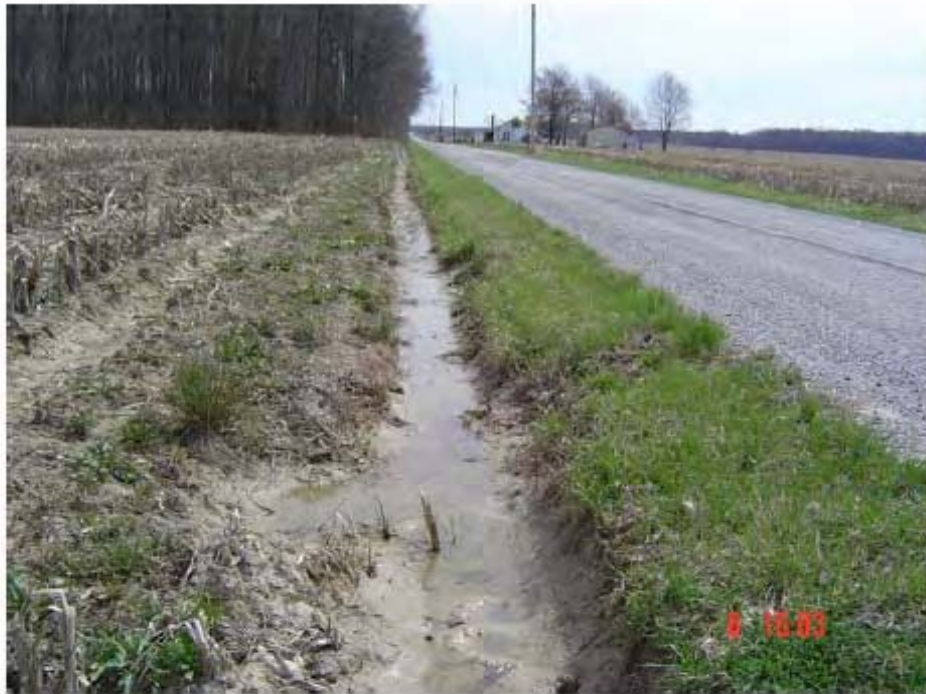
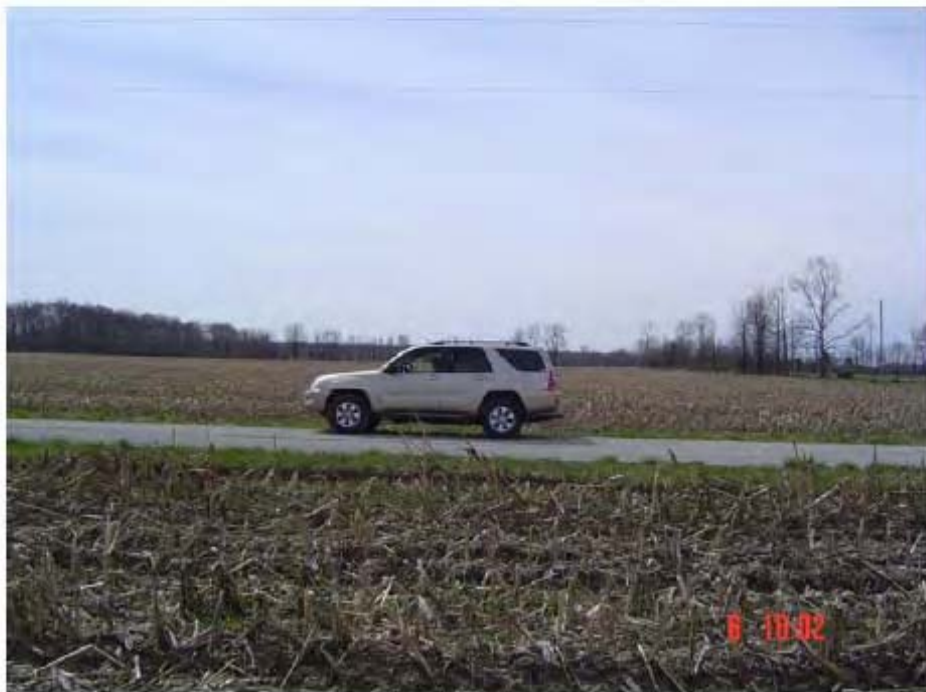
4. OLS 292 in Area 10 (Figs. 13–17). Although flat to the eye and smooth except for corrugations due to normal tilling and tractor tires, OLS 292 crossed a paved road. Soil on the OLS was very wet and soft, with standing water in some tractor tire ruts. A single pole line runs along the road edge, and ditches parallel the road sides. The pavement is asphalt and is nearly two vehicle widths wide. The road is visible as a lighter tone in the LANDSAT image used to locate the OLS (Fig. 18).

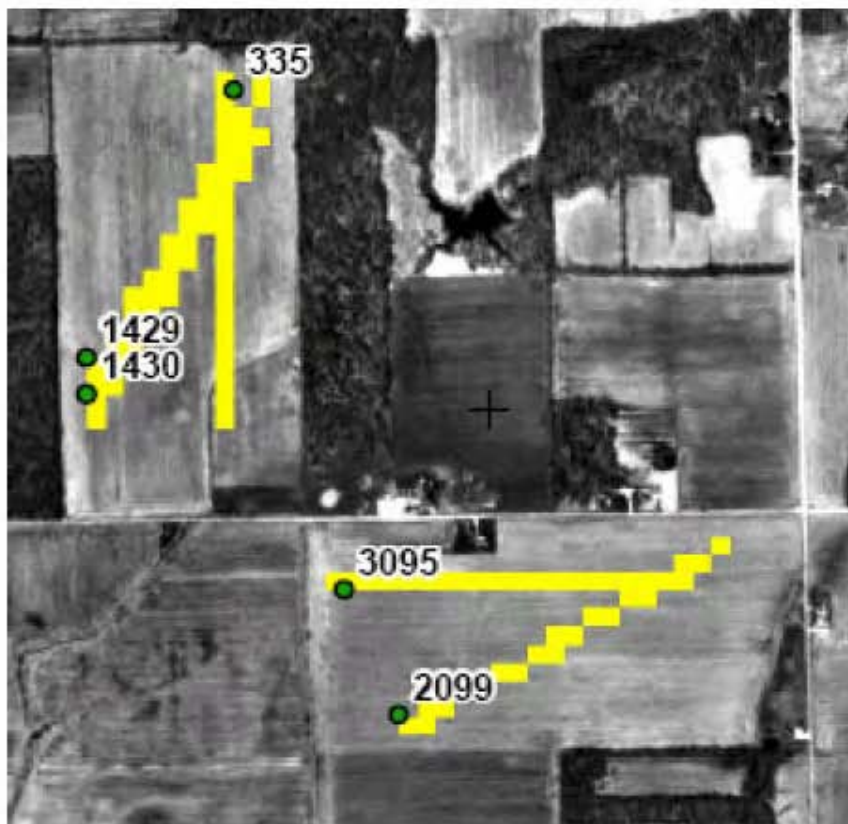
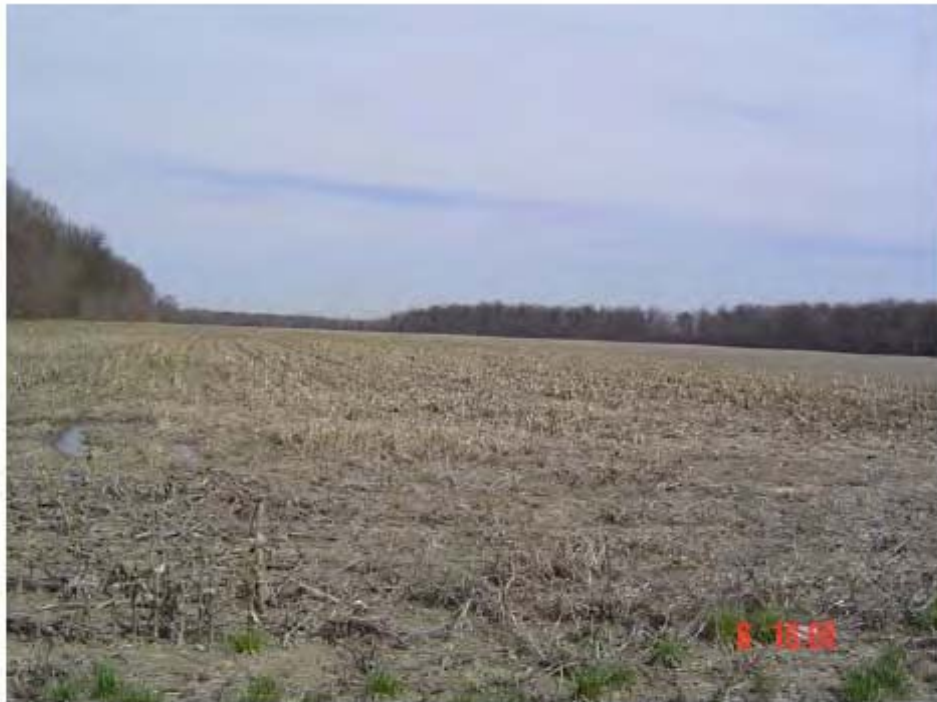
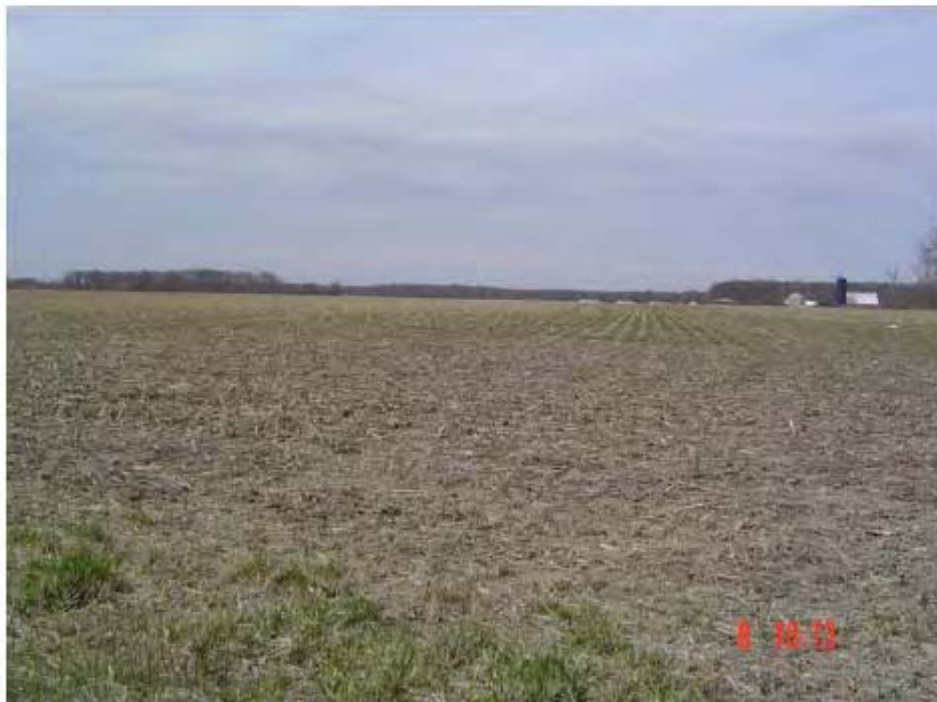
5. OLSs 335, 1429, 1430, 2099, and 3095 Area 10 (Figs. 19–21) all cross corn fields. These fields were not walked. However, they appear flat and free of obstruction. Both fields had been cropped with corn the previous year and exhibited the typical corn stubble and tillage and farm implement rutting. Both fields were wet, although little standing water was observed.

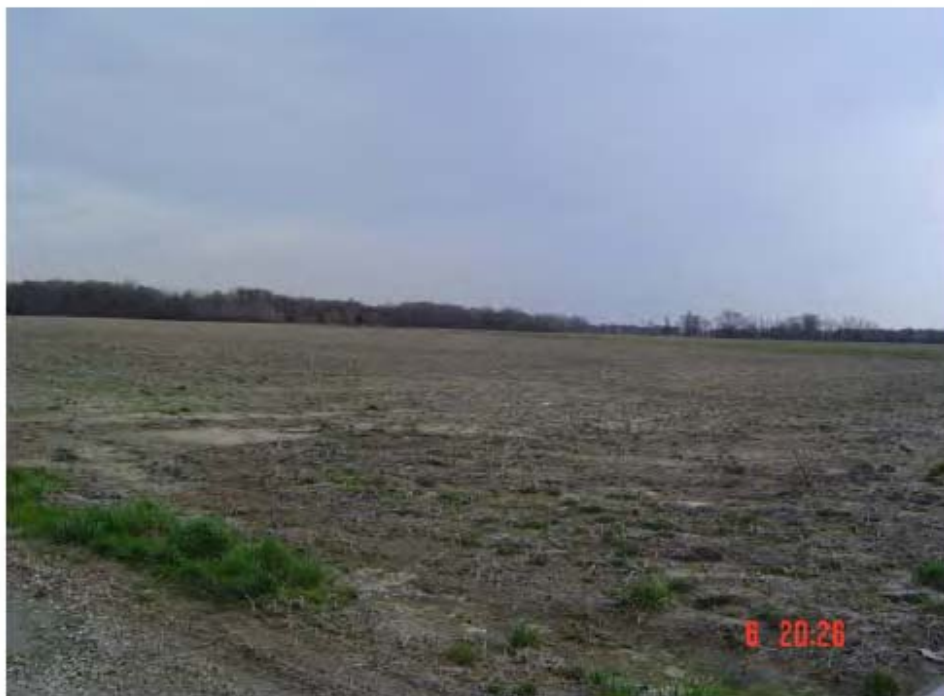
Figure 22.

6. Area 5 includes a field with a large cluster of OLSs, both yellow and red, indicating that most (yellow) were selected with the less strict greenness index of 1.8, and several were selected with a more strict greenness index of 1.7 (red) (Fig. 22). The field appears to be level, smooth, and flat; it appears to have been cultivated the previous year in soybeans, leaving less agricultural debris on the surface than found in cornfields (Figs. 23 and 24). Several OLSs are oriented east-west and, thus, appear to be free of obstructions. However, the majority of OLSs are oriented either north-south or northwest to southeast. It appears that all of these north-south trending

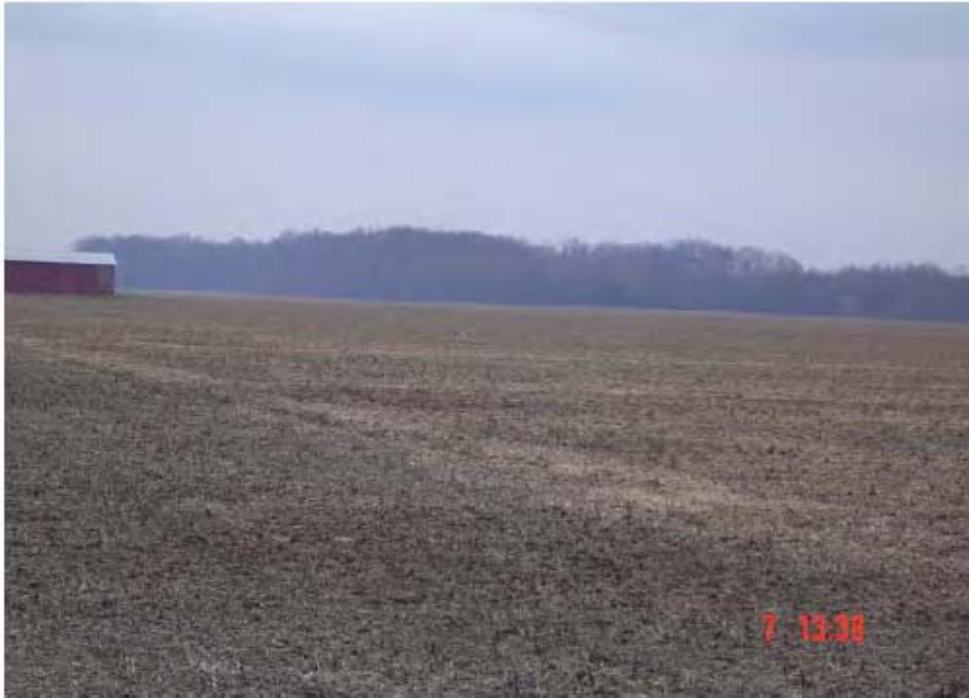
Figure 35.

8. Area 7 contains three clusters of OLSs. The cluster that contains OLSs 1373, 1375, 3663, 2557, and others was inspected because it was close to a road and could be readily evaluated (Fig. 35). Figure 36 shows the location of this cluster, which is on smooth, flat land. Notably, the OLSs are oriented such as to miss the barn in Figure 36—a notable achievement.

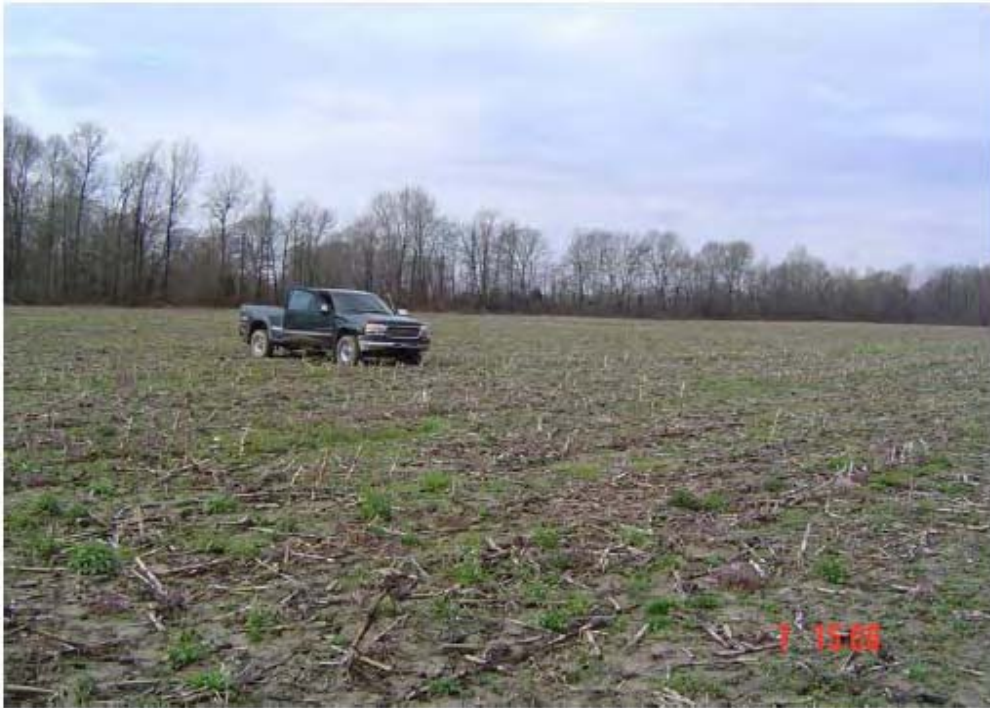
Figure 37.

9. Figure 37 shows two OLSs on the western side of Area 6 encompassing OLSs 1458 and 1459. Figure 38 shows a ground view. These OLSs were chosen for later field work. The software located the OLSs, avoiding hills, valleys, and other obstacles.

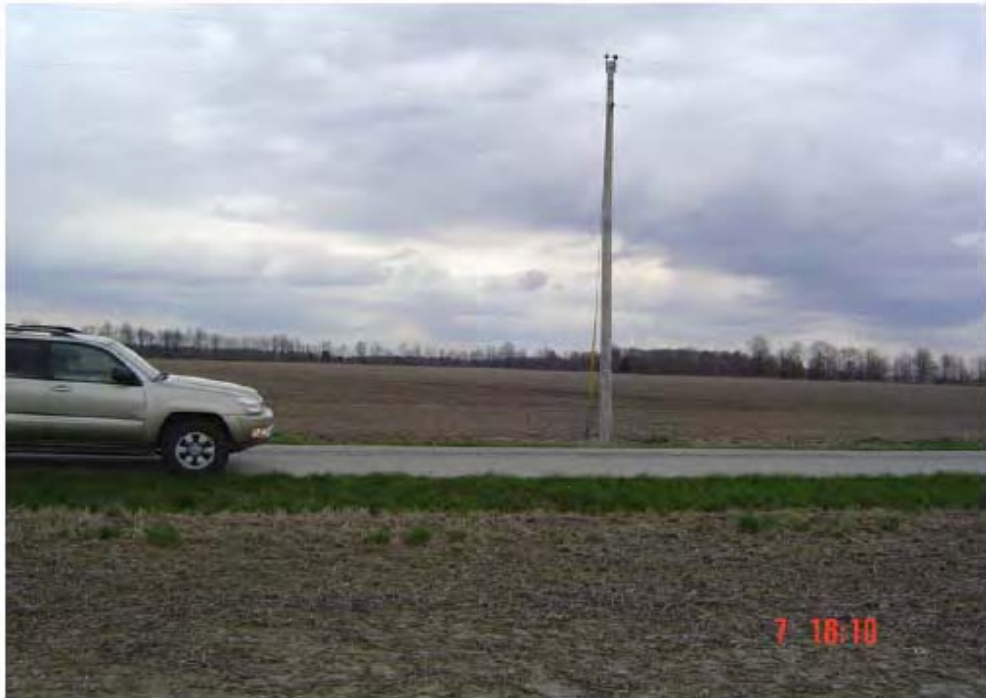
Figure 39.

10. OLSs 460 and 461 are in Area 12, situated on gently rolling land (Figs. 39 and 40). The OLSs cross a road (Fig. 40).
 11. OLSs 819, 4091, 3636, 3051, 3052, and 3053 are located in the southern end of Area 16 (Figs. 1 and 41). OLS 3053 crosses a road, whereas all of the other OLSs appear not to cross obstructions. Figures 42–44 show the two ends of OLS 3053 and the area where the road is crossed. Except for the road crossing, OLS 3053 appears to be flat and free of obstructions.

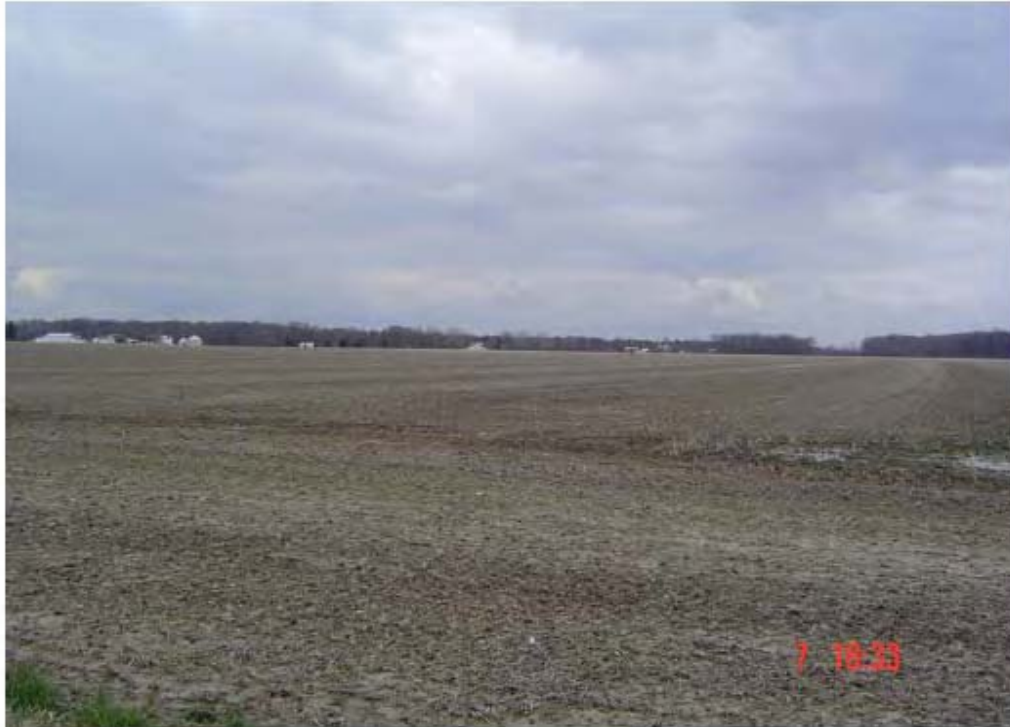
Figure 45.

12. Figure 45 shows additional OLS clusters in Area 16 (Fig. 1). Figure 46 shows the fields where many of these OLSs are located—largely flat and free of obstructions except for some standing water. However, Figure 47 shows where OLS 831 crosses a road with a relatively deep drainage ditch on one side and a paralleling single-pole power line.

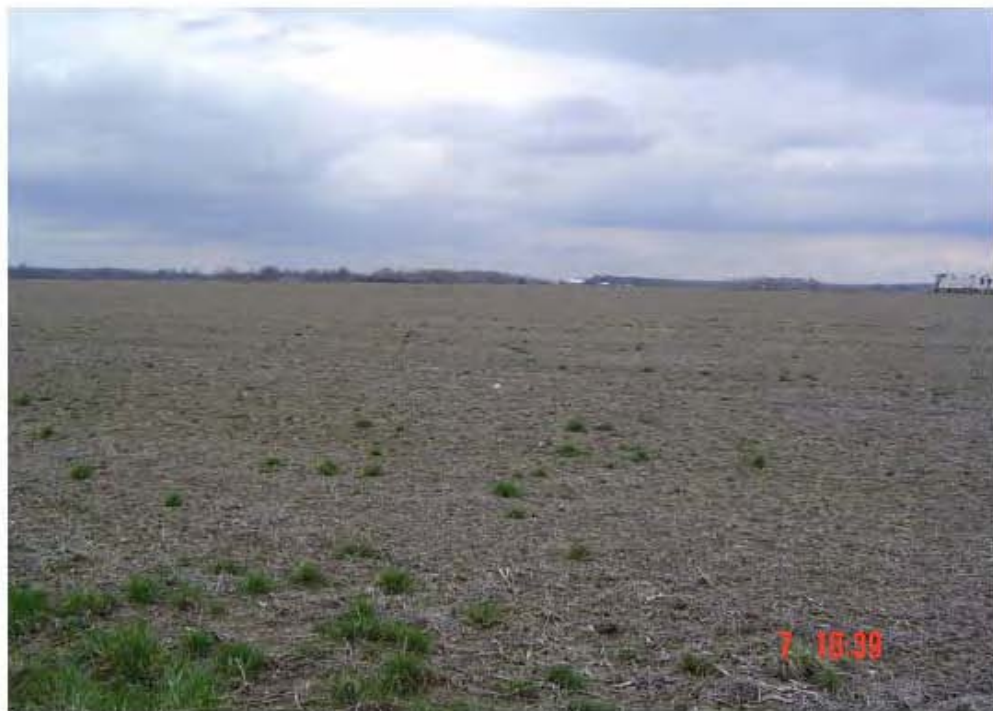
Figure 48.

13. Figure 48 shows a cluster of OLSs in the northern portion of Area 16 (Fig. 1). Figures 49 and 50 show where most of the OLSs are located north and south of the road that crosses through the western end of the cluster. These many OLSs appear to cover flat fields with no obstructions.
14. Figures 51–53 show OLSs located on the eastern side of Figure 48—primarily east of the north-south road. The landscape is largely flat and free of obstructions. However, some east-west trending OLSs appear to cross the north-south road beyond the stop sign in Figure 51, and are also visible in Figure 53.

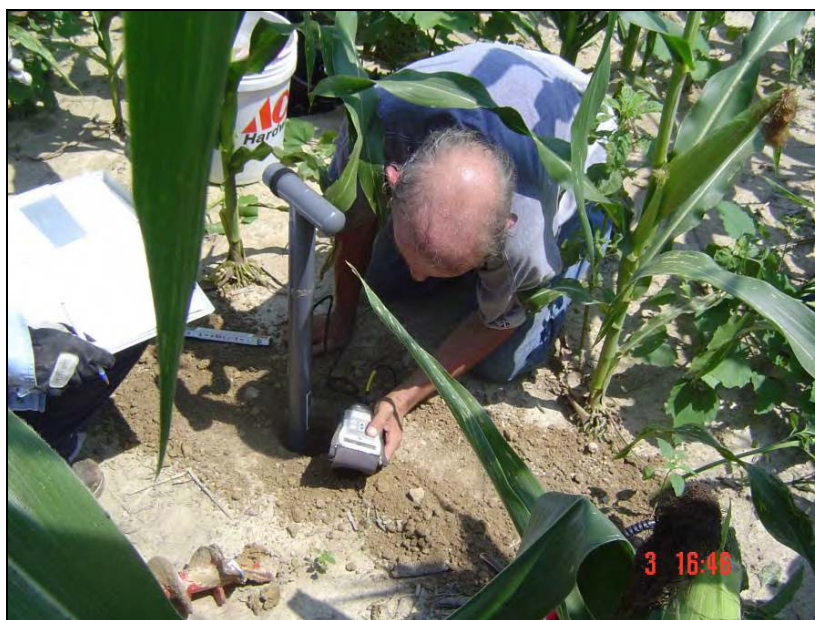
Figure D-1. Using ML2 and HH2 readout to measure soil moisture at depth within auger hole.

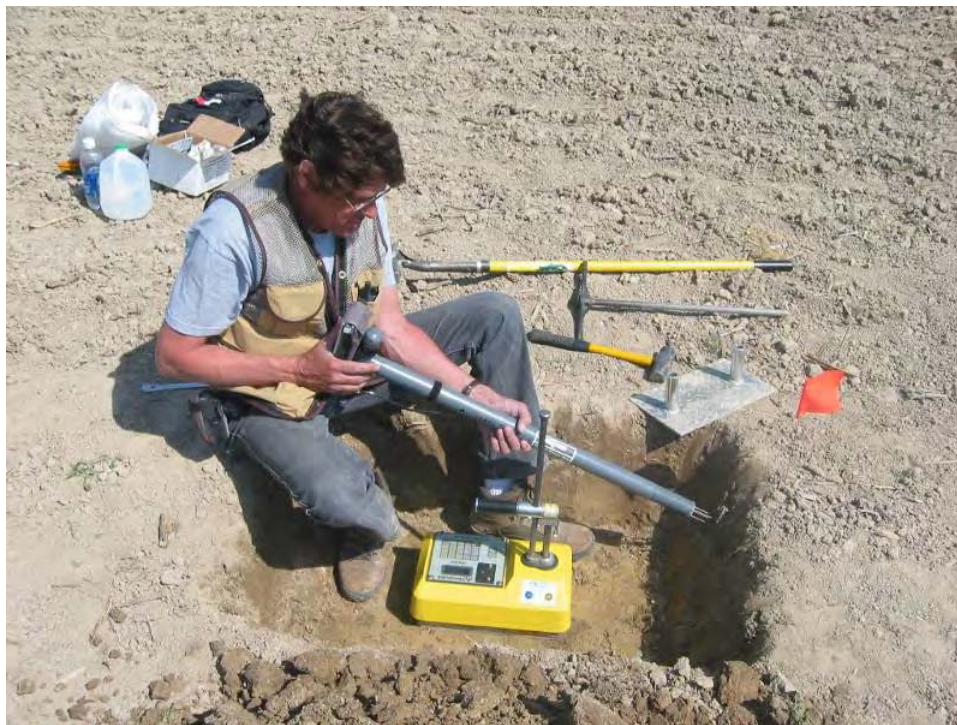
Figure D-4. Troxler nuclear gauge (yellow instrument) in moisture-reading configuration at the base of the soil pit. The Dynamax ML2 is held ready for measurement of soil moisture content, with the four stainless steel measuring rods visible at the right pit wall.
